Subject: Standard Initial Foundation Repair Evaluation
Slab Foundation
2023 Wilshire Dr, Irving, TX

LIMITED REPAIR PLAN

2023 WILSHIRE DR, IRVING, TX

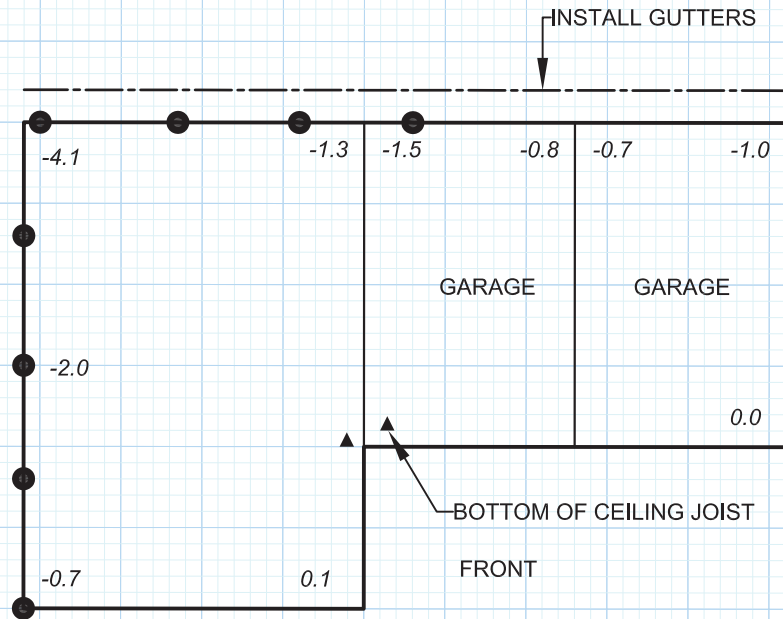
A relative elevation floor survey was performed using a Zipllevel Pro-2000B to map the surface topography of the floor of the living area and garage (if present). The floor plans and the elevations are illustrated on the limited repair plan. The elevations were adjusted based on the flooring type encountered to be on the same plane as the base point floor type. If a garage was present, the garage ceiling was measured and adjusted to be on the same plane as the foundation. Garage floors are designed to slope and are not as effective in measuring foundation movement.

Brick cracks, foundation cracks, brick line deflection, and ponding water were observed. Based on our observations of the structure, the structure’s physical damage, and review of the elevation map, we believe the structure has experienced foundation movement over the life of the structure, resulting in differential movement of the slab on grade foundation.

Damage observations were most notable on the back and left sides of the structure and are correlated with floor elevation data.

We recommend installing 8 exterior pilings in the approximate locations of the structure as indicated on the limited repair plan. We also recommend installing and maintaining a full guttering system with downspout extensions and a foundation watering system. The purpose of the piling installations is to support the failed areas and improve elevations in areas of differential settlement if possible. Please see the limited repair plan for more information. The foundation repairs are to meet or exceed 2015 IRC.

INSTALL 8 EXTERIOR PILINGS, FULL GUTTERING SYSTEM W/ DOWNSPOUT EXTENSIONS, FOUNDATION WATERING SYSTEM
